Slope degradation and analysis of Mokattam plateau, Egypt

M. EL-Sohby & M. Aboushook

Keywords: Mokattam city, Eocene, landslides, marl, shale, edge failure, water infiltration

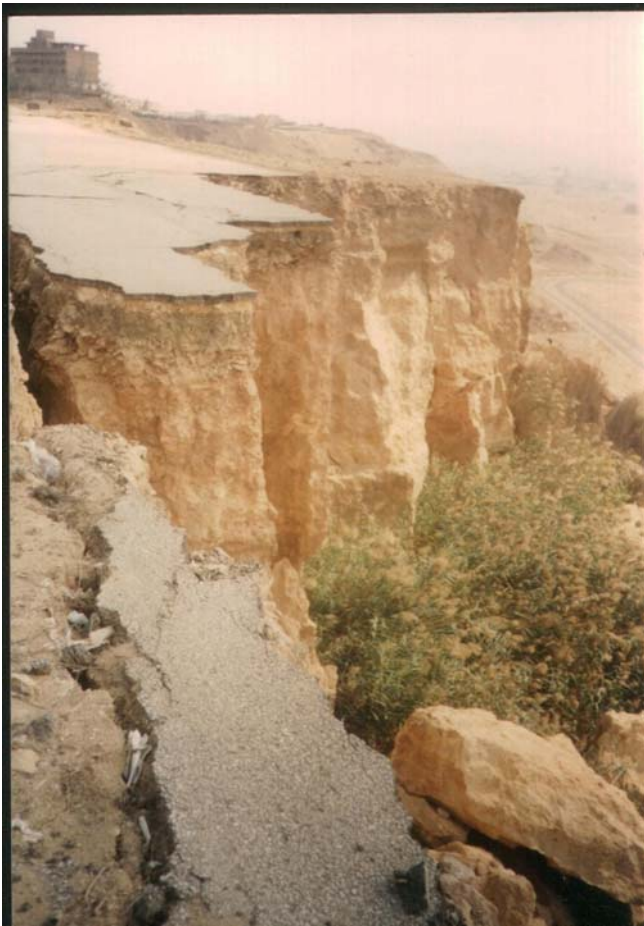
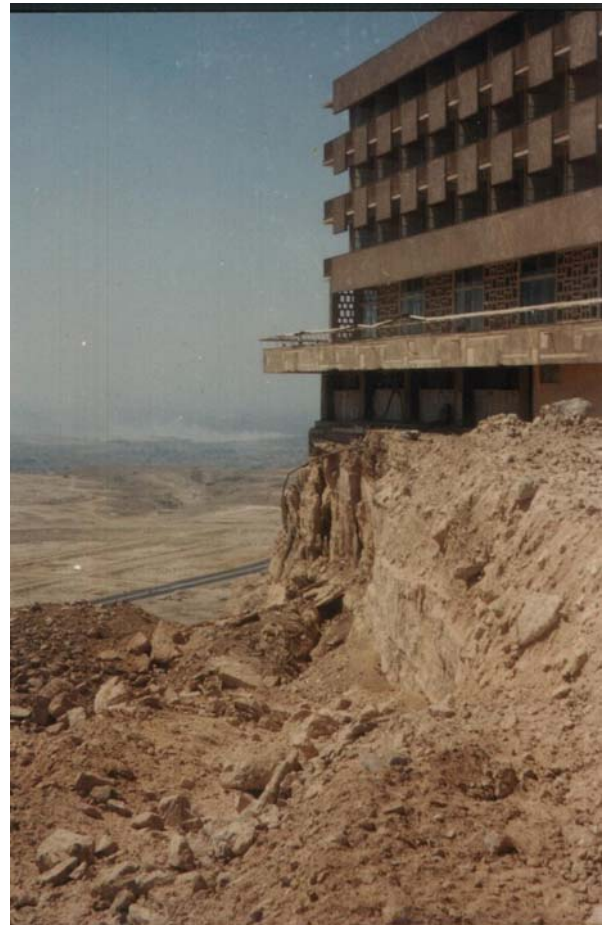
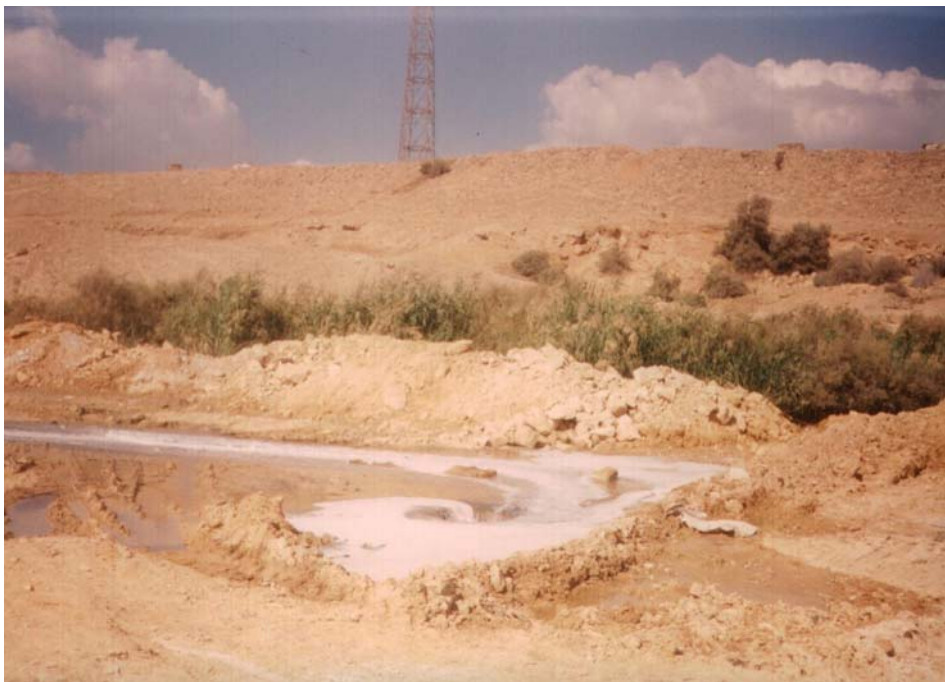
rock falls were observed. The most significant of this was an edge failure that occurred in front of a five-storey hotel. The rock mass that slipped reached the edge of this hotel and left the corner column almost overhanging (see photos). Since then, several investigations on the incidents were launched to assess the causes, future hazards and probable protective or mitigation measures (EGSMA, 1996; El-sohby and Eleboudy, 1988; El-sohby et al. 1987 and Elleboudy, 1985). However, the studies were usually for particular zones and addressed local failures.

Some photos showing land slide activity
